NAUGATUCK RIVER BASIN
SEYMOUR, CONNECTICUT

BLADENS RIVER DAM
CT 00602

PHASE I INSPECTION REPORT
NATIONAL DAM INSPECTION PROGRAM

MARCH 1980

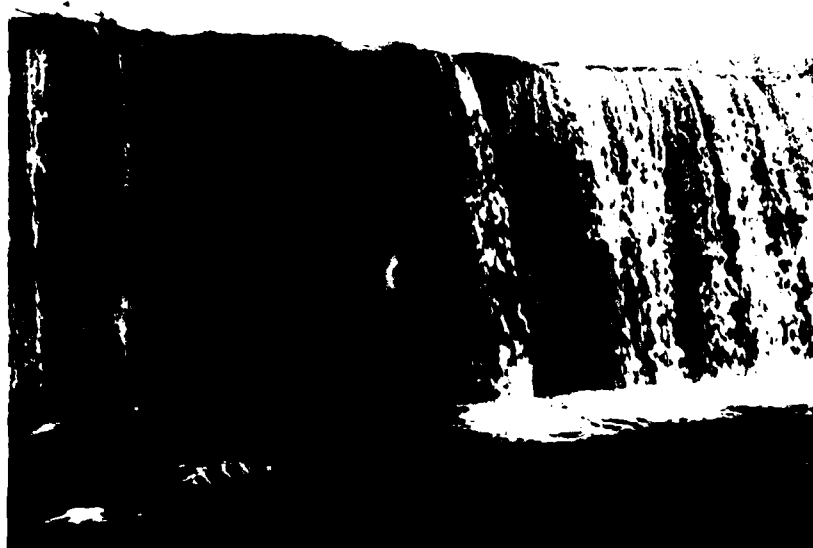
PHOTO NO. 10

The spillway sections of the dam and the auxiliary spillway of the forebay discharge into the natural streambed of the Bladens River. Bedrock outcrops were observed in the streambed at the right side of the dam, as shown in Photo 10.

RIGHT END OF AMBURSEN-TYPE
BUTTRESS SECTION. NOTE BEDROCK OUTCROP.
